Smoke and Dye Testing Summary

High Level Sewershed

Test ID	Test Type	Date Inspected	Company / Super.	Blower MH	Ground Condition	Notification Made?	Total Length
S1028-066	Smoke	9/8/2008	ADS/TM	S13II1021MH	Dry	Yes	2,157.37

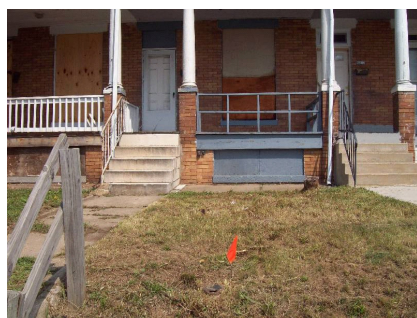
Picture \S1028-066-OB01-P01.jpg

Comments Smoke from cleanout in front yard. 4313 Park Heights Ave

Comments Front of house, 4313 Park Heights Ave

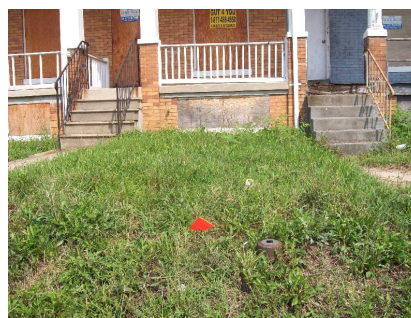
Picture \S1028-066-OB02-P01.jpg

Comments Smoke from cleanout in front yard. 4307 Park Heights Ave

Comments Front of house, 4307 Park Heights Ave
